## 2019 Inspection of the Milne Inlet Tote Road and Associated Borrow Sources

PRESENTED TO  
**Baffinland Iron Mines Inc.**

OCTOBER 30, 2019  
ISSUED FOR REVIEW  
FILE: ENG.EARC03171-01

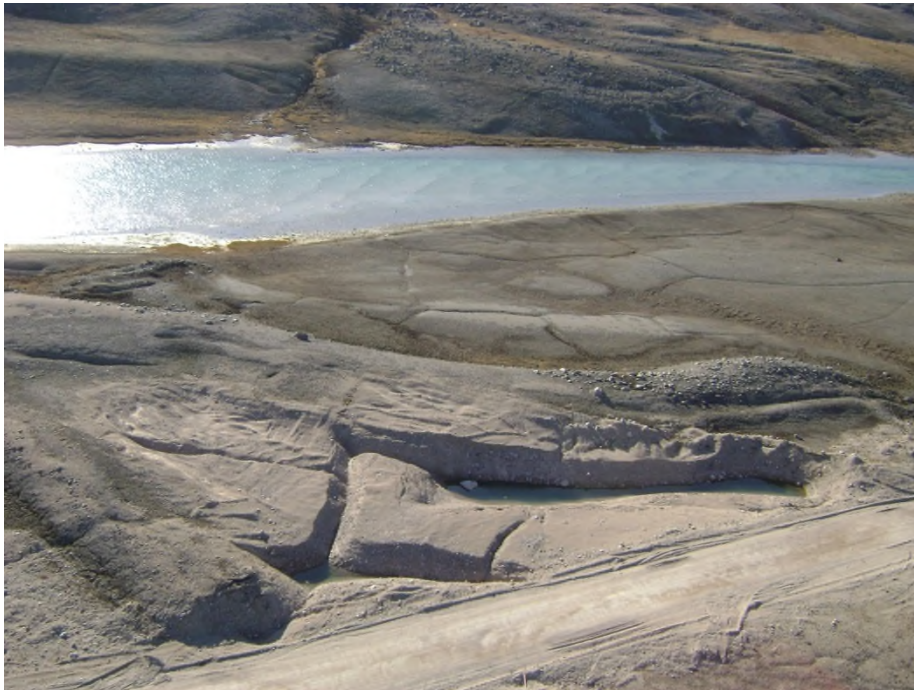
**Photo 2 (2014 Photo 1585):**

Pit at KM 20.7 (Figure 2), linear sinkholes from ice wedge melt out, see also Photo 3.

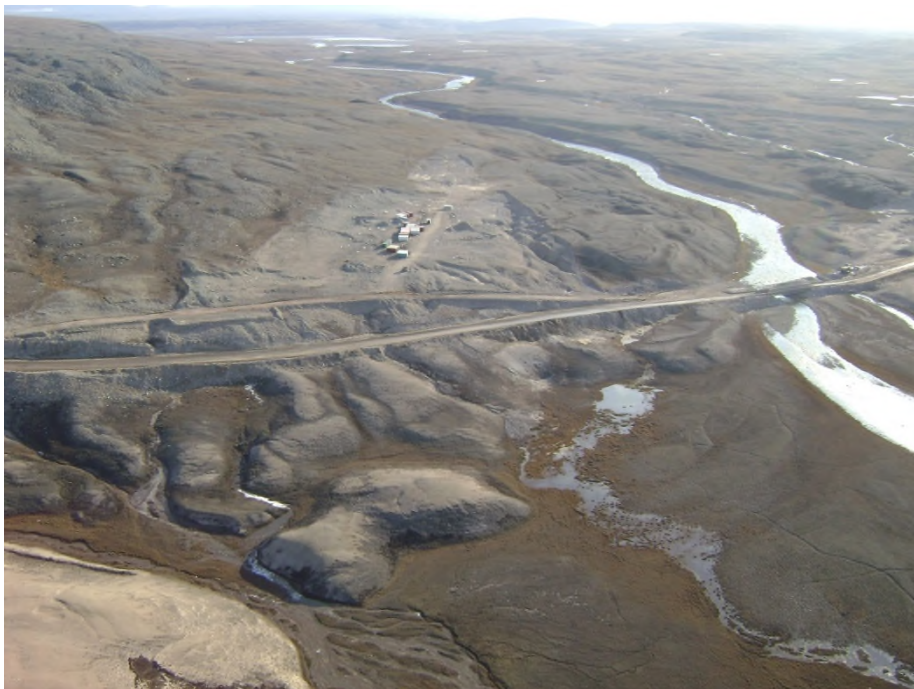
**Photo 5A (2593):**  
Pit at KM 61.7 (Figure 8), in 2014, note extensive settlement in southern portion (right side) of the developed pit indicative of the presence of massive ice in portions of this deposit. Note road realignment to improve grade.

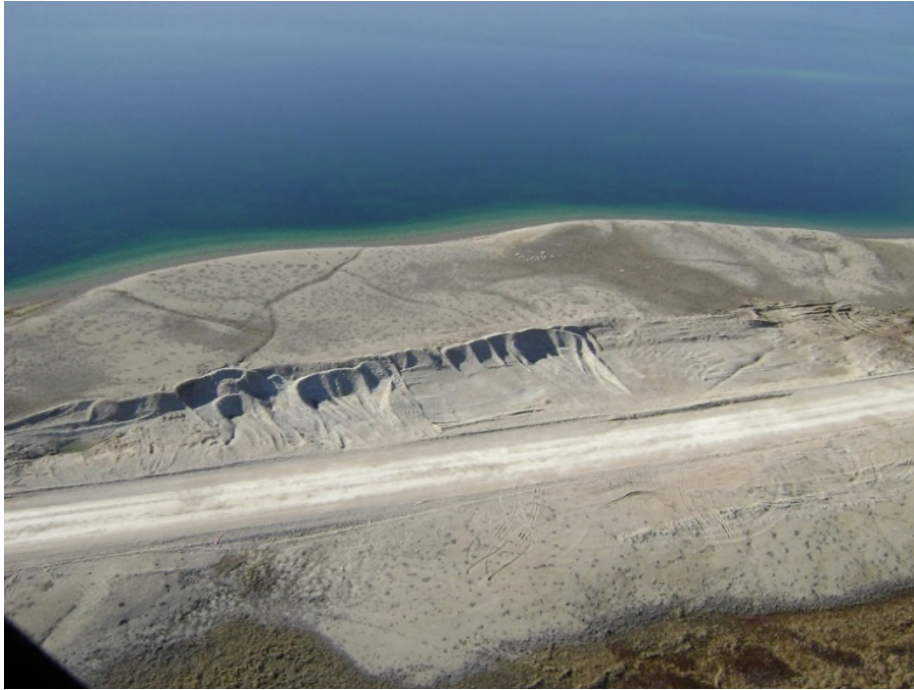
The sites identified as Priority C are the least sensitive and could generally be reclaimed by site grading and dressing of the slopes. A typical Priority C site is shown in Photo 6. The Priority A and B sites are judged as not currently stable and therefore will require attention directed to the ongoing thaw of permafrost and surface water management. The following discussion provides guidance for planning reclamation that will address these objectives. The Priority A++++ sites warrant immediate attention because there is a potential for failure of the road surface which is particularly worrisome given the significant increase in haul traffic that is now using the road.

**Photo 6 (2014 Photo 1576):**  
Pit at KM 32.4 (Figures 4 and 5), typical Priority C pit in thaw stable soils that only requires regrading.

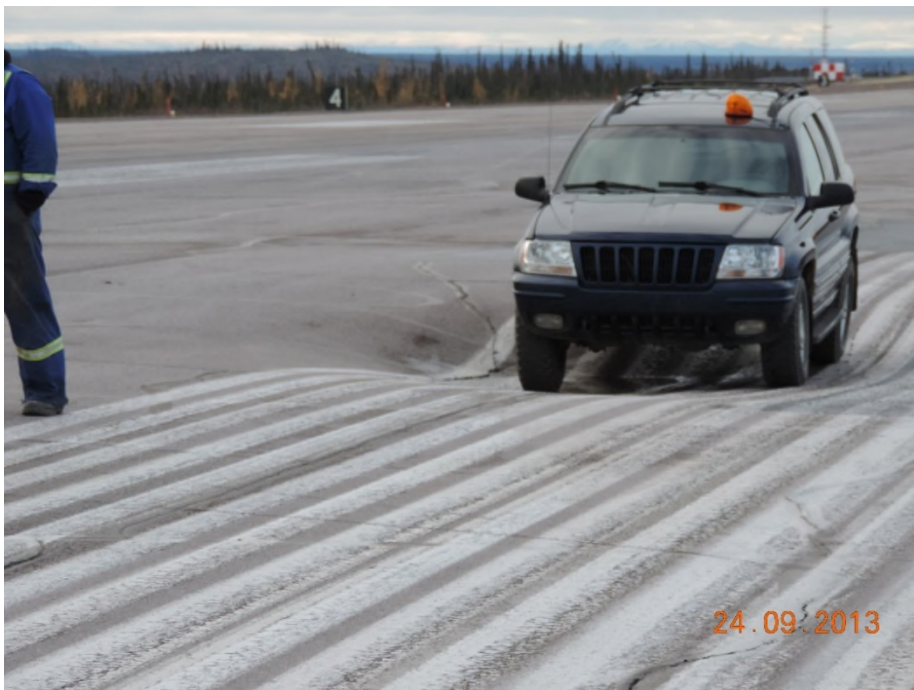
**Photo 7:**  
Extreme settlement of the runway at the Inuvik, NT airport. Settlement appeared overnight. Investigation revealed that the settlement occurred due to thaw of an ice wedge below the embankment. The embankment had bridged the void left by the thaw for a considerable length of time (likely several years).

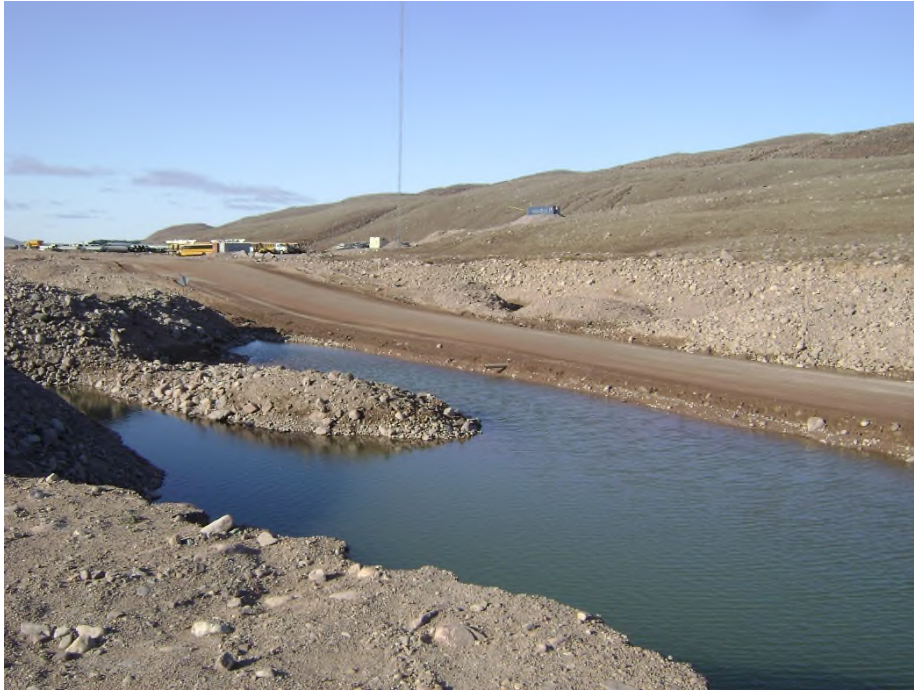
1. KM 7.2 (pit 83A) – See Photos 8 and 9. Considerable water is trapped in the ponds created due to thaw of massive and wedge ice. Embankment is unstable, and water appears to be quite deep on the right side. Water should be removed as much as possible and pit backfilled with material to retard thaw and provide stability to the road.
2. KM 7.9 (pit 83) – See Photo 10. Ponded water is causing thaw and cracking of the embankment side slopes. Ponded water could lead to thaw under the embankment. Water should be removed, and pit backfilled to enhance permafrost aggradation that will provide stability to the road. Care will be needed to provide protection against erosion.

**Photo 8 (2531):**  
Pit at KM 7.2 with water on both sides of the new road alignment and extensive thaw of massive and wedge ice.

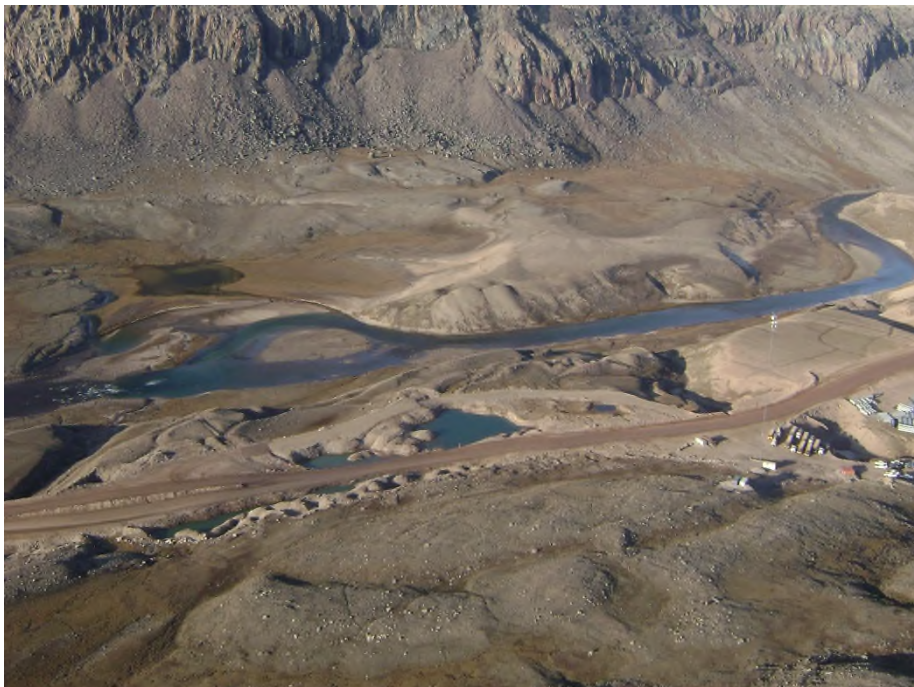
**Photo 9 (2578):**  
Pit at KM 7.2 – Note extensive thaw ponds on the west (right) side of the road. The road has been significantly realigned since 2014 and thaw has progressed dramatically since then. Road is likely founded on permafrost that contains massive ice thereby raising concern that thaw due to the ponded water could lead to failure.

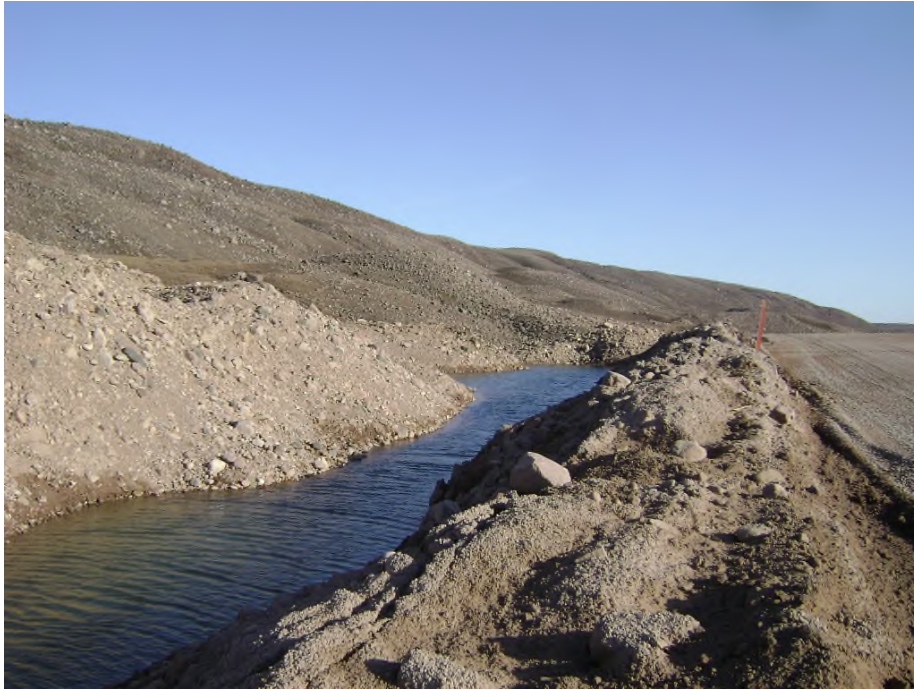
**Photo 10 (2536):**

Pit at KM 7.9 showing extensive settlement and ponding that is leading to embankment instability.

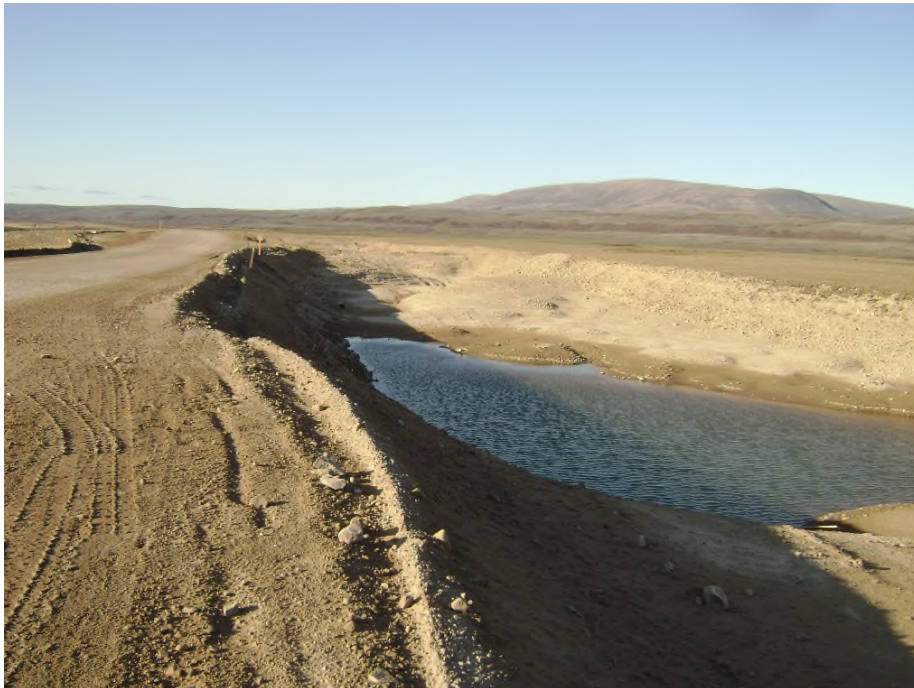
**Photo 11 (2540):**

3. KM 19.8 (pit 72) – See Photos 11 and 12. Thaw of very ice-rich ground continues in this pit. Side slopes are too steep, and the shoulder and side slopes show signs of instability. To guard against catastrophic failure, this pit should be backfilled or at a minimum a 2.0 m or so high berm should be placed along the toe of the steep slopes to provide stability and push ponded water away from the toe of the slope.

Pit at KM 19.8 (Figure 4), pit is deepening due to continued thaw of ice-rich ground. Side slopes are very steep and there is considerable cracking on the shoulder and side slopes indicating that thaw is progressing under the road embankment. See Photo 12 for an aerial view of this pit.

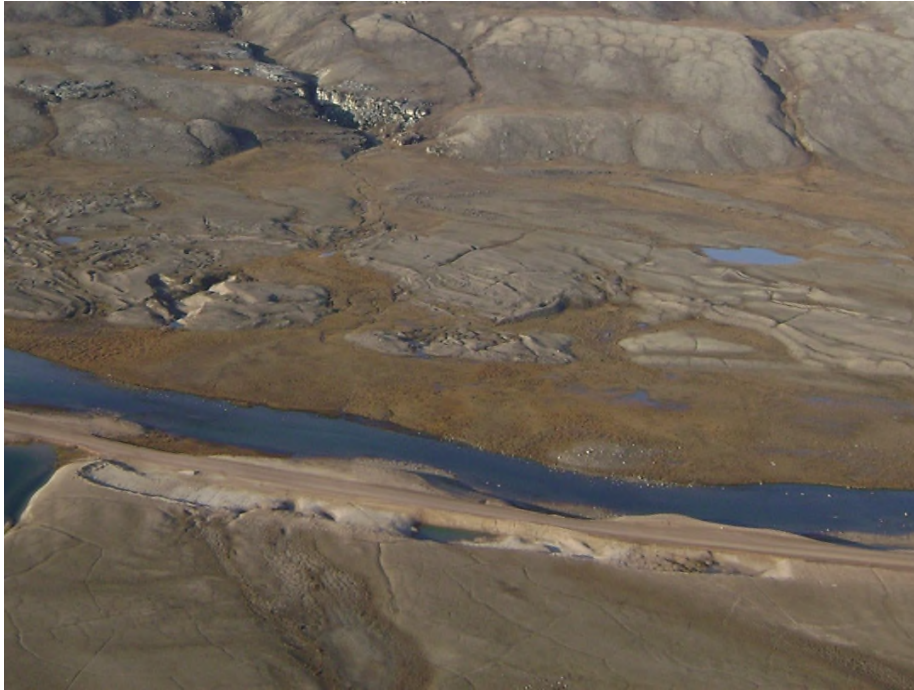
**Photo 12 (2571):**

Pit at KM 19.8 (Figure 3), note ponded water resulting from thaw of ice-rich material and over-steepened side slopes where water is ponding.

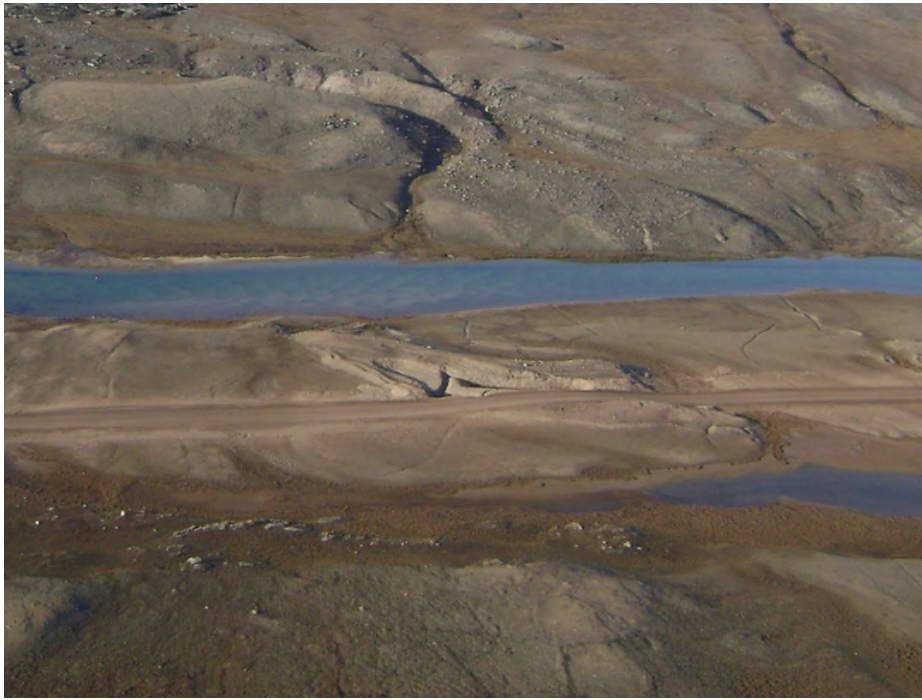
4. KM 20.7 (pit 71) – See Photos 13 and 14. Continued thaw of wedge ice is increasing settlement depth and there continues to be evidence that the ice wedge ground that the road is constructed on is thawing. This pit should be backfilled, and the surface regraded to cause the permafrost to aggrade and thereby stabilize the embankment side slopes and hopefully arrest thaw of the wedges below the embankment.

**Photo 14 (2571):**  
Pit at KM 20.7 (Figure 3), see Photo 13 for closeup of this pit.

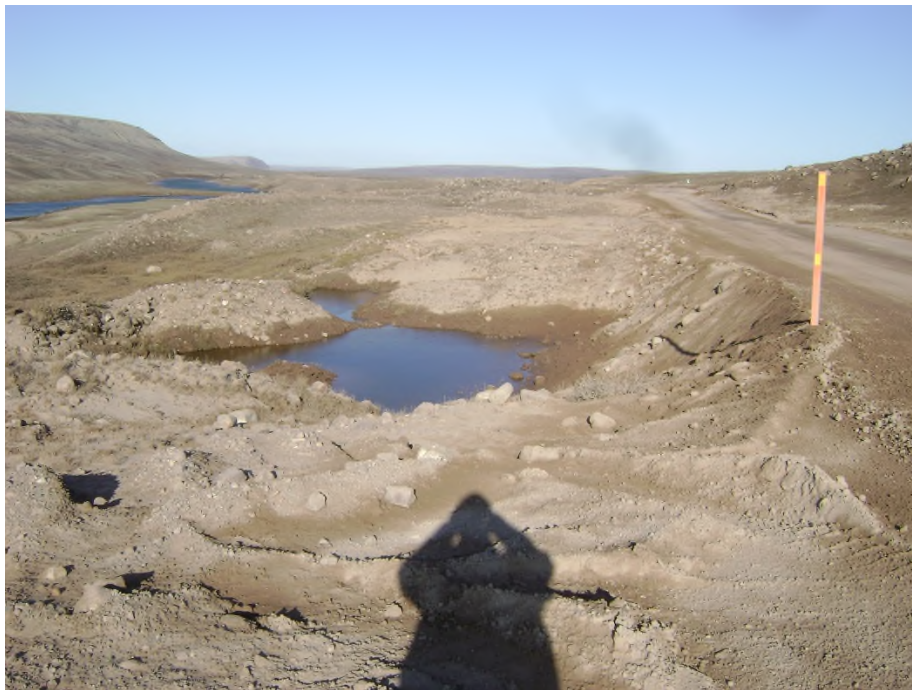
**Photo 15 (2693):**  
Pit at KM 21.9 (Figure 3), continued thaw of ice-rich material exacerbated by the ponding leading to steep side slope and instability of the embankment.

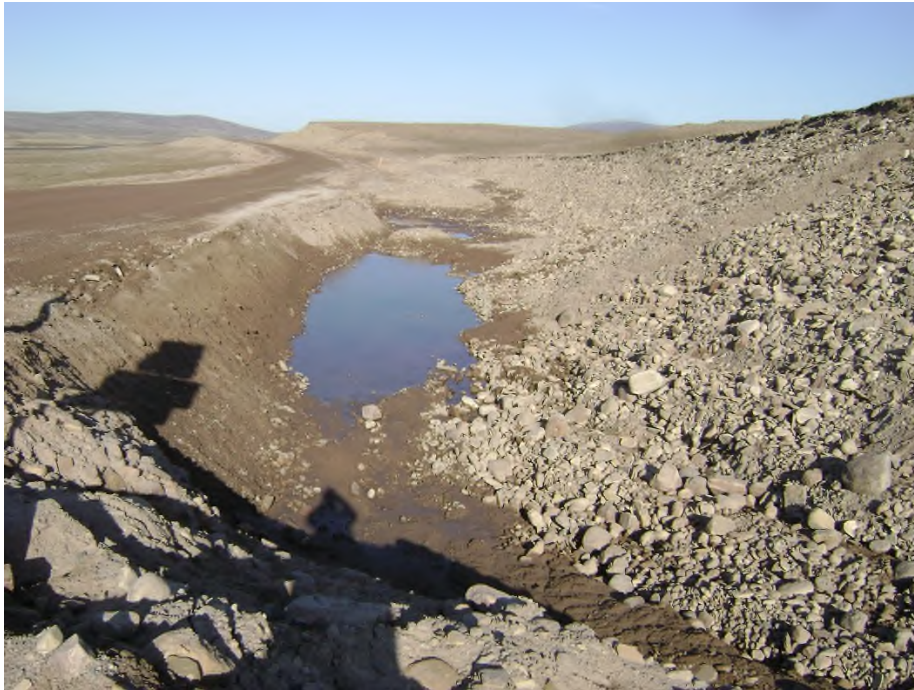
**Photo 16 (2693):**

Pit at KM 29.1 (Figure 4), continued thaw of ice-rich material exacerbated by the ponding leading to steep side slope and instability of the embankment. See also Photo 17. The central portion of this pit had been backfilled since 2014 dramatically improving embankment stability.

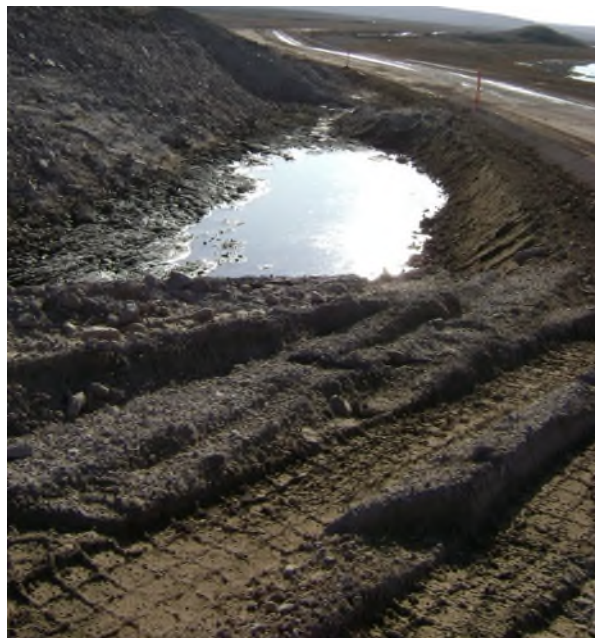
**Photo 17 (2695):**

Pit at KM 29.1 (Figure 4), continued thaw of ice-rich material exacerbated by the ponding leading to steep side slope and instability of the embankment. The central portion of this pit had been backfilled (bottom of the photo) since 2014 dramatically improving embankment stability.

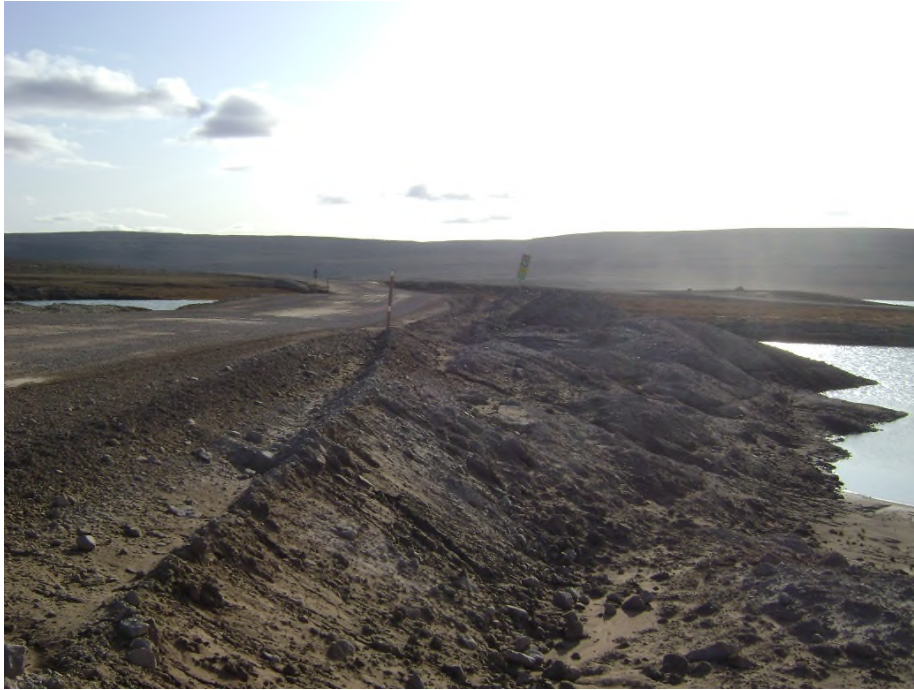
**Photo 18 (2670):**

7. KM 56.7 to 56.9 (pits 32 and 33) – See Photos 18,19, and 20. The new road alignment runs through the old pit which had experienced extensive melt out of ice-rich permafrost. The old embankment is now failing quite significantly. Water is ponding on both sides of the new road bringing concern of instability as further thaw is expected. Drainage from the pond on the left of the embankment passes through the new embankment through a culvert into the area between the new and the old road, from there it flows towards the lake (see Photo 20). With no maintenance on the old road there is concern for the continued performance of the culvert on the old road. If it was to fail or become blocked, water levels beside the new road would rise significantly perhaps leading to more thaw along the new road. Two remedial measures are therefore suggested. Provide wider berms along the full length of both sides of the new road (like those shown in Photo 18) or backfill the old pit in its entirety. Also, remove the culvert on the old road and breach the road so continued reliance on the old culvert is not required.

Pit at KM 56.8 (Figure 8), berms along this (right) side of the new road effectively push water away from the embankment providing thermal protection to the embankment foundation soils and enhancing stability.

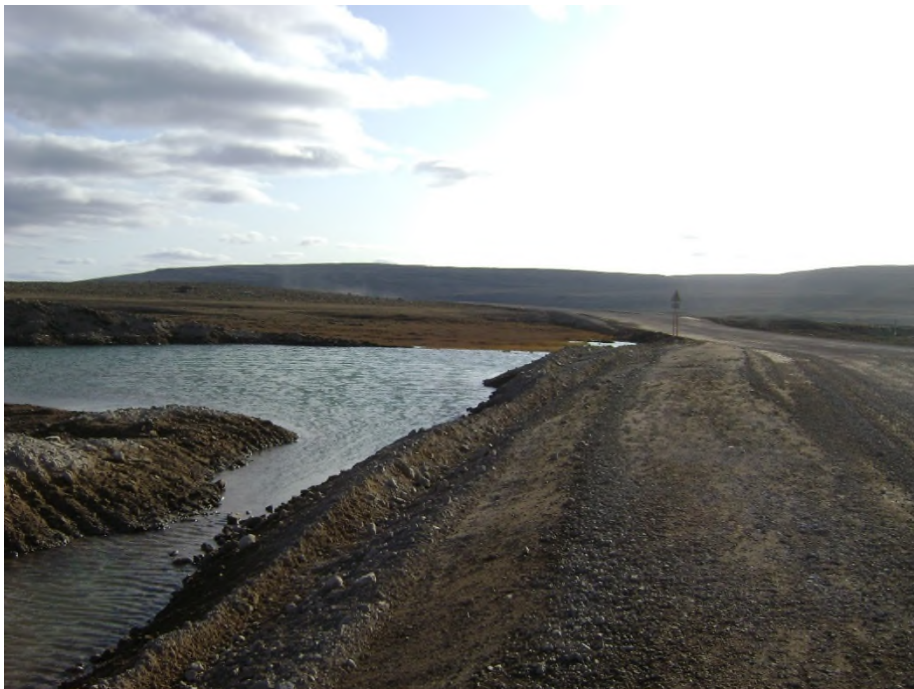
**Photo 19 (2693):**

Pit at KM 56.8 (Figure 8), the left side of the new road has steeper side slopes particularly where it narrows at the culvert inlet (close to the KM marker). This increases the potential for instability. The water needs to be pushed back from the toe of the slope by constructing berms on this side of the road (see Photo 18).

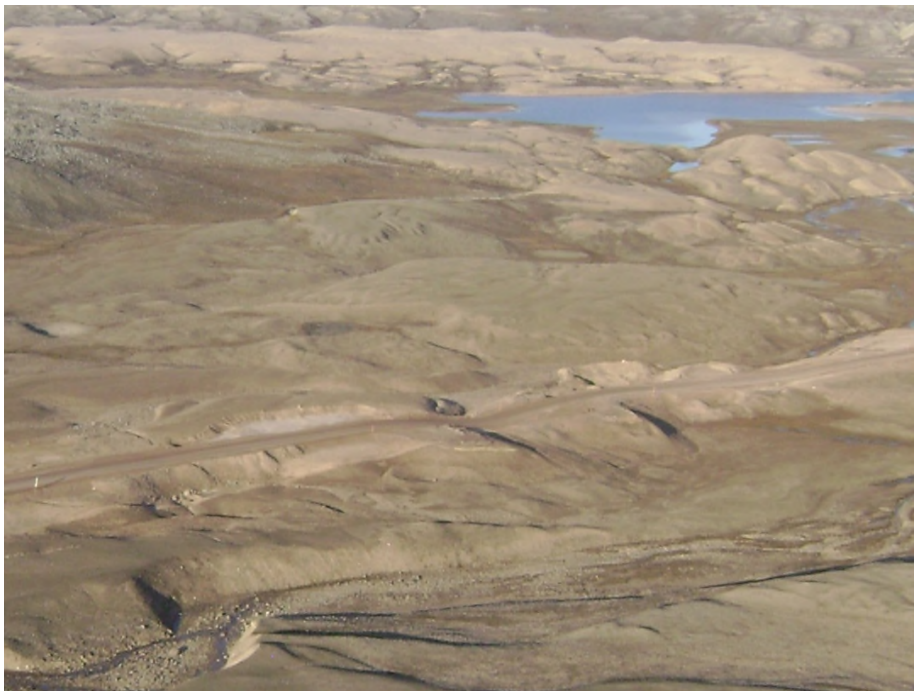
**Photo 21 (2558):**

Pits at KM 63 to 63.8 (Figure 9), continued thaw of ice-rich material threatens road stability at this location.

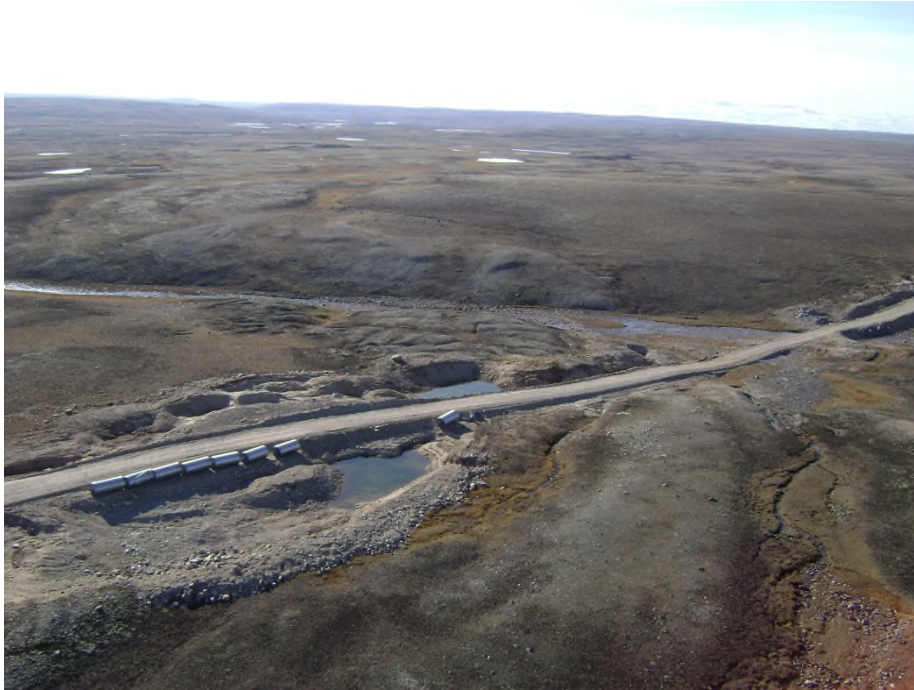
**Photo 24 (2014 Photo):**

Pit at KM 72.4 (Figure 10), extensive thaw settlement of very ice-rich soils in the borrow pits on both sides.

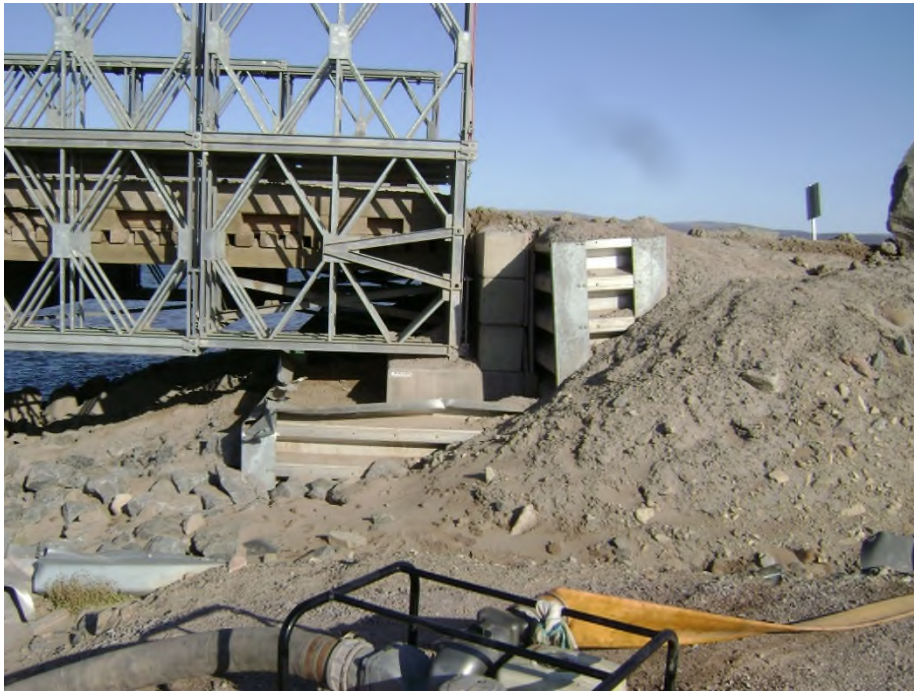
**Photo 34 (2715):**  
KM 80 Bridge, south abutment. Note tilting of upper bin wall.

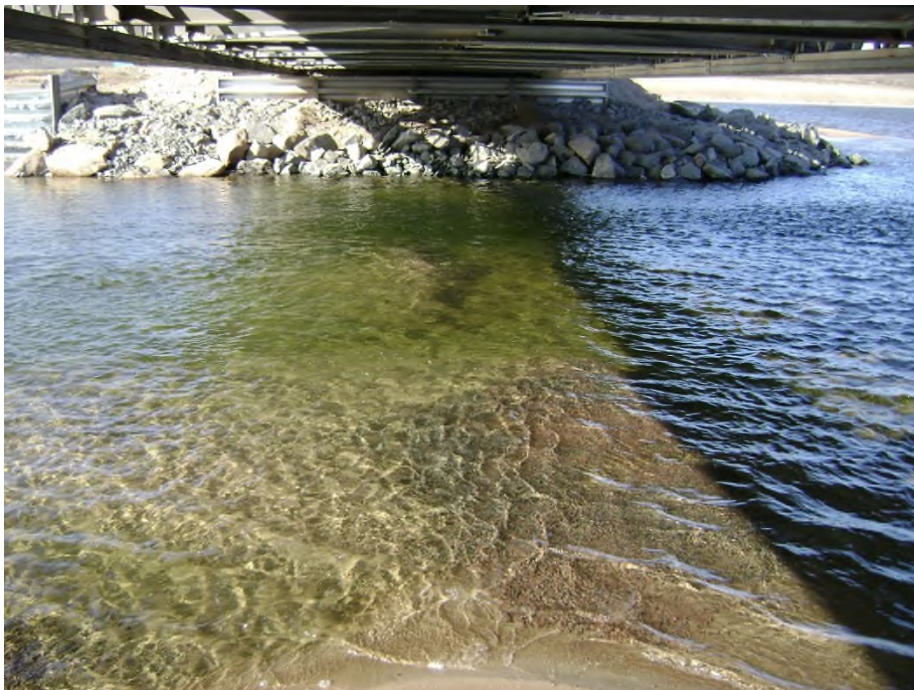
**Photo 35 (2718):**  
KM 80 Bridge, road surfacing gravel that has fallen through the centerline joint in the bridge deck and is visible in the river.

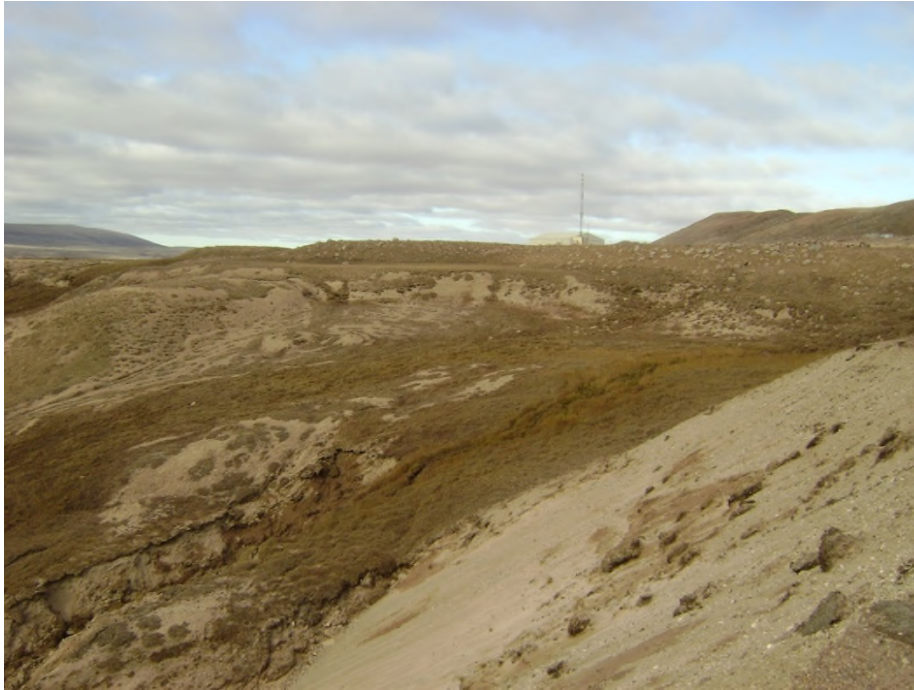
**Photo 40 (2528):**  
KM 4.0 erosion location immediately below the culvert on the north side of the terrace.

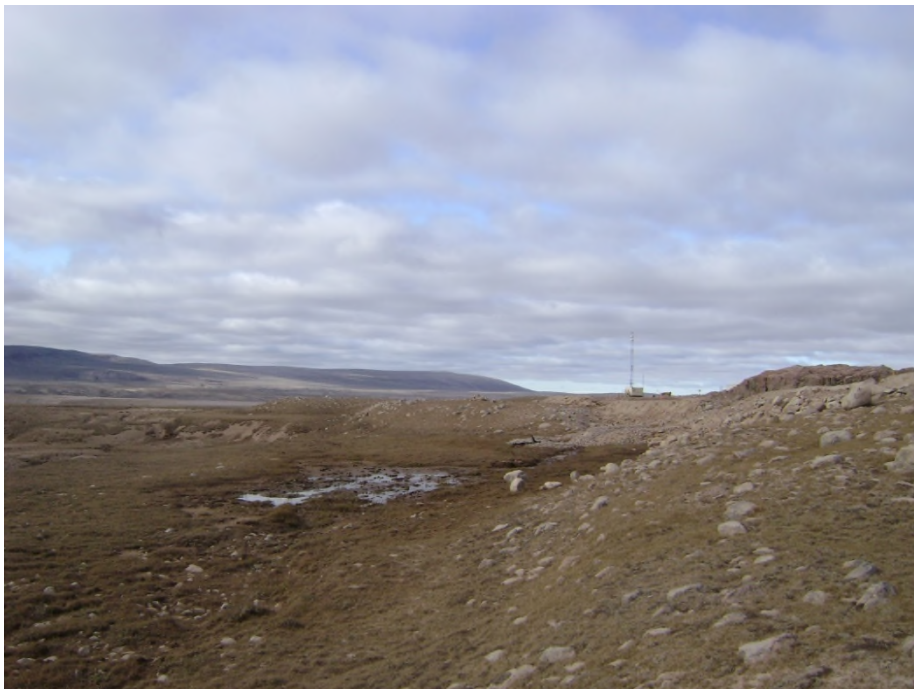
**Photo 41 (2526):**  
KM 4.0 erosion location. Photo shows wet area below the road on the top of the terrace.

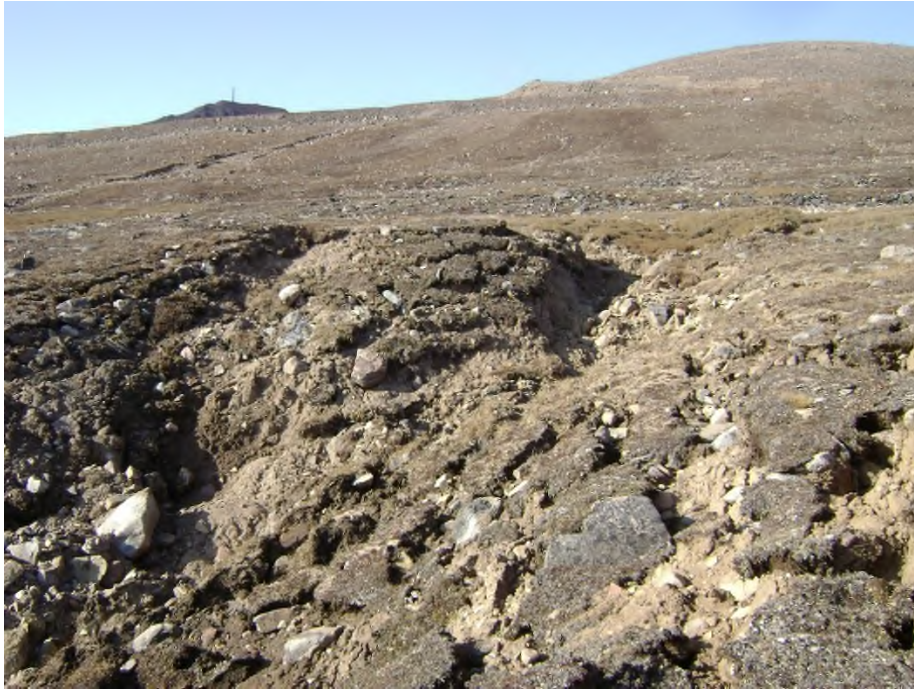
**Photo 50 (2652):**  
Close-up of some of the erosion channels downslope of the main mine haul road from the open pit.

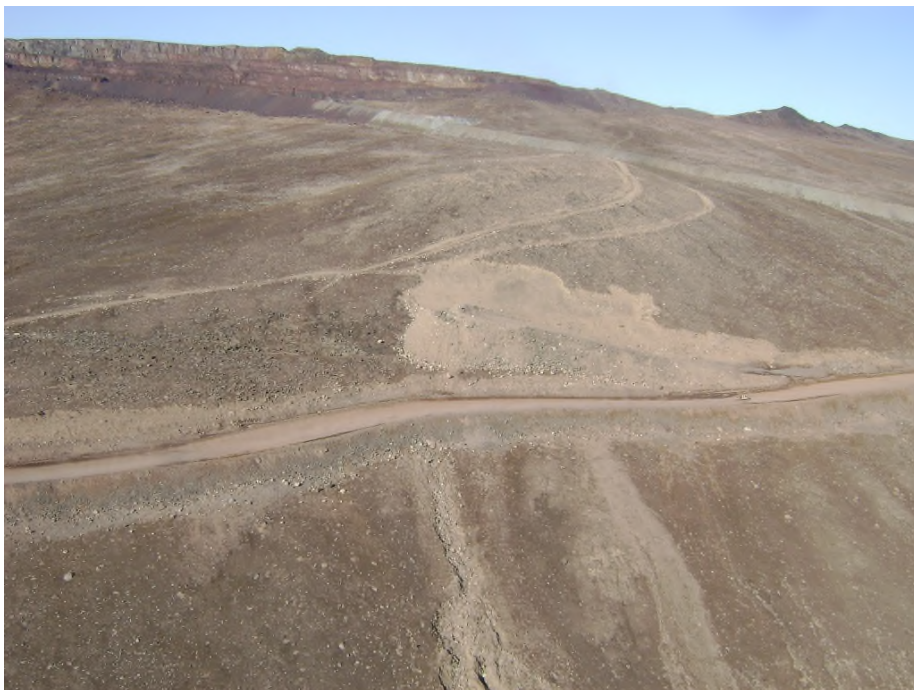
**Photo 51 (2643):**  
Additional erosion channels downslope of the main mine haul road from the open pit.
