APPENDICES

APPENDIX A
CONCORDANCE TABLES

Concordance Table - Type A Water Licence 2AM -MRY1325

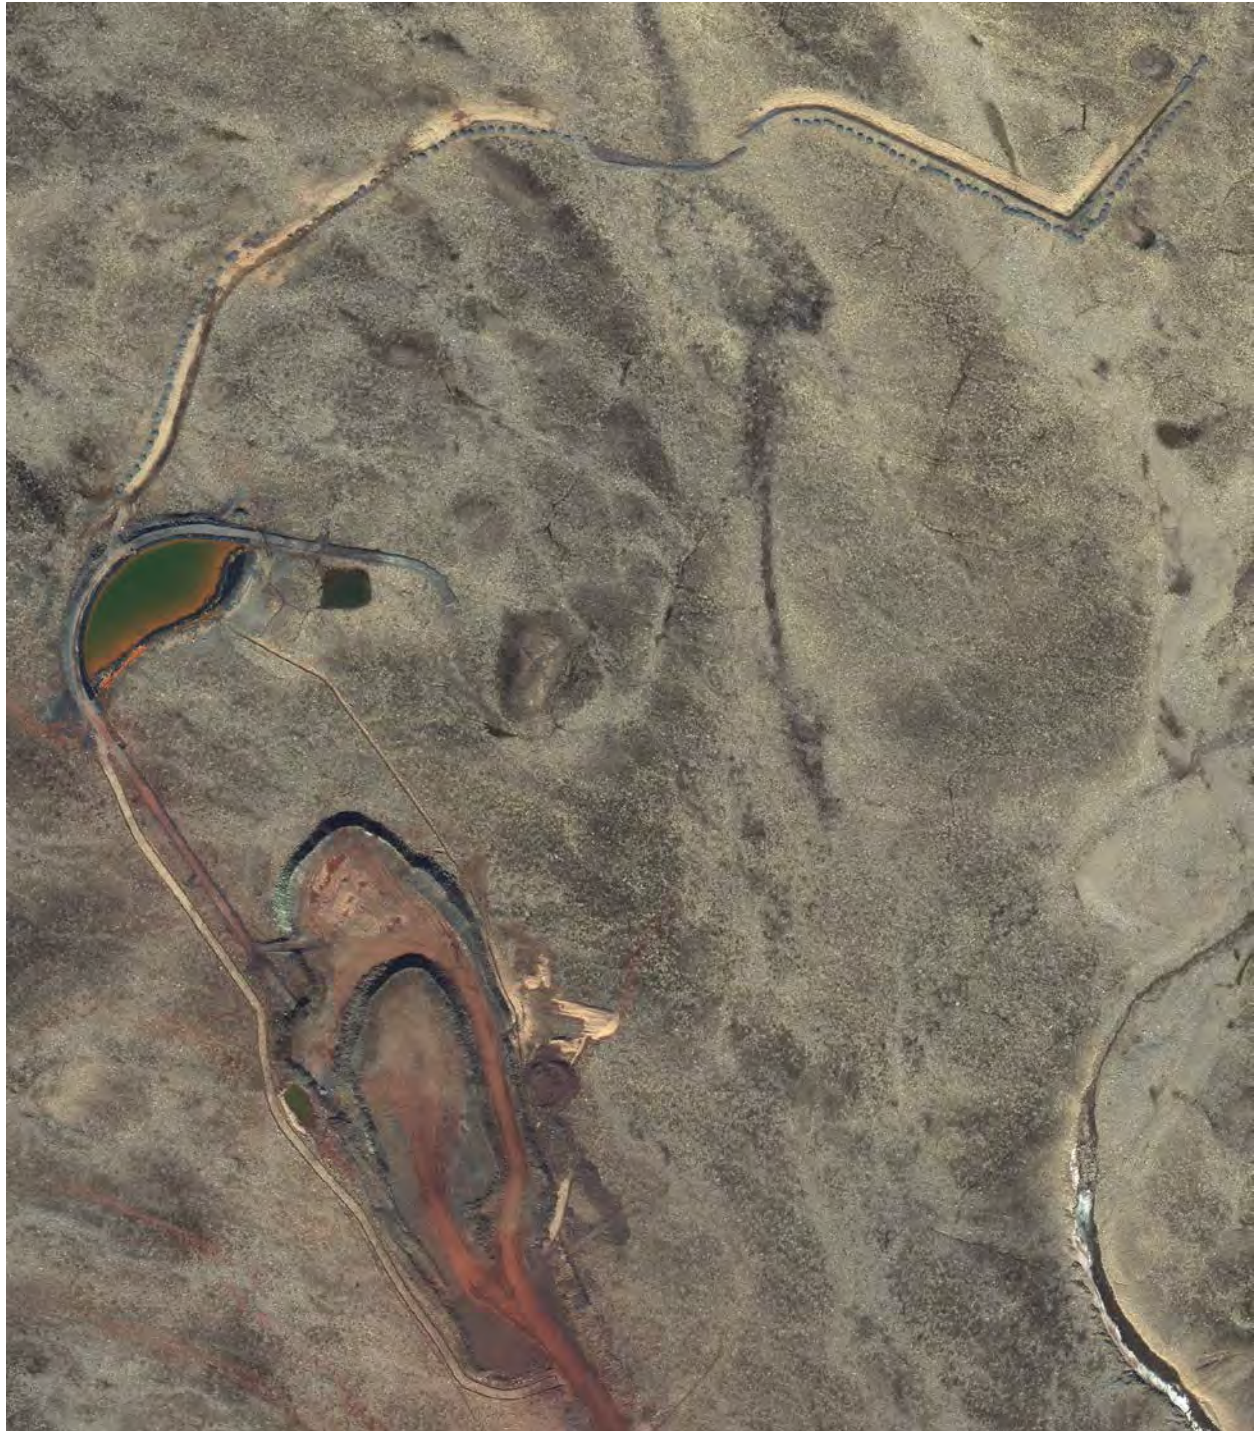
Figure 1: Aerial View of Waste Rock Stockpile, Pond and Ditch

- In some areas the design slope of 2:1 on the ditch walls was found to be too steep for the original ground material and the walls were collapsing during construction. A field decision was made to increase the slope up to 3:1 to achieve a stable ditch wall.
- The drainage slope of the ditch was reduced in the field due to differences in design topography data and that found in the field. As a result of this slope reduction the original ground was built up in some areas to achieve the bottom of ditch elevation. Ditch walls were built up from the elevation of the raised ditch bottom.
- In August 2017, after construction of the pond and ditch was completed, three additional ditches were dug upstream of the pond to direct water in to the pond, one in the centre of the pond and one at each end.

- The perimeter key that is designed to retain the pond liner on the upstream side of the pond collapsed due to poor ground conditions. As a result of this collapse, the liner lifted and allowed water under the liner. To remediate this issue, the liner was cut back and re-buried.
- There is a concern that water may be migrating underneath the liner in one location. Baffinland’s Environmental Department is investigating this issue.

- The liner key on the high side of the pond perimeter is built in to the original ground. During the 2016 summer, the liner key collapsed as a result of the poor ground conditions. To repair the pond, the liner was cut back and re-buried.

- In the summer 2015 construction period, the bottom of the ditch between 0+100 and 0+325 was over excavated and back filled. During the 2016 summer construction period, the back fill in this area became unstable and had to be removed and replaced with waste rock.

- During construction of the ditch, the project ran out of rip rap, so one 125m long section of the ditch does not have rip rap installed. Rip rap will be installed in this section in 2017.
- An annual inspection and maintenance program for the ditch is recommended. The high volume of ground water and the poor quality of the original ground may result in movement of placed rip rap in to the original ground. The 50m section of ditch closest to the discharge point is of particular concern.

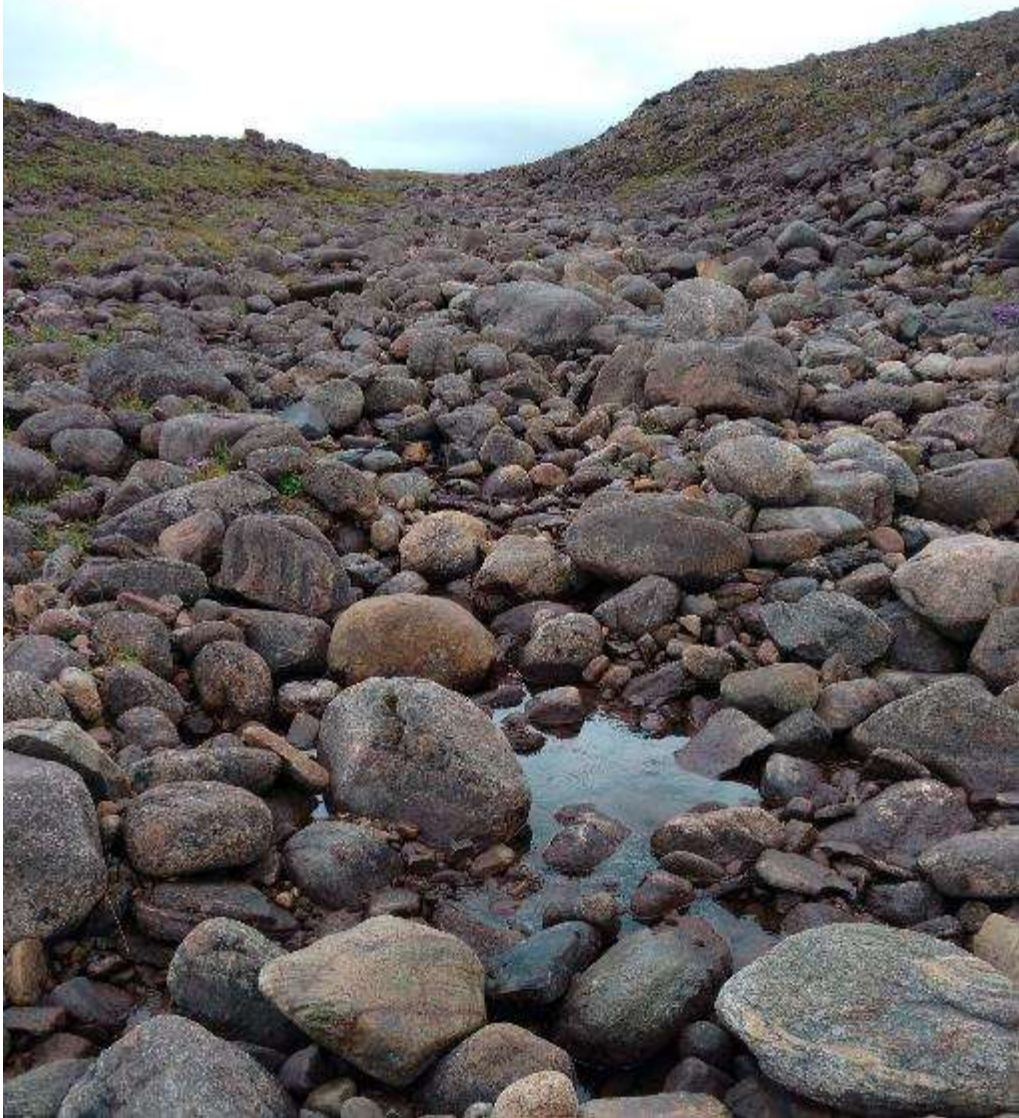
Photo 3 – Flow conditions at Landfill Gate Tributary on July 19, 2016
