## 2019 Inspection of the Milne Inlet Tote Road and Associated Borrow Sources

PRESENTED TO  
**Baffinland Iron Mines Inc.**

OCTOBER 30, 2019  
ISSUED FOR REVIEW  
FILE: ENG.EARC03171-01

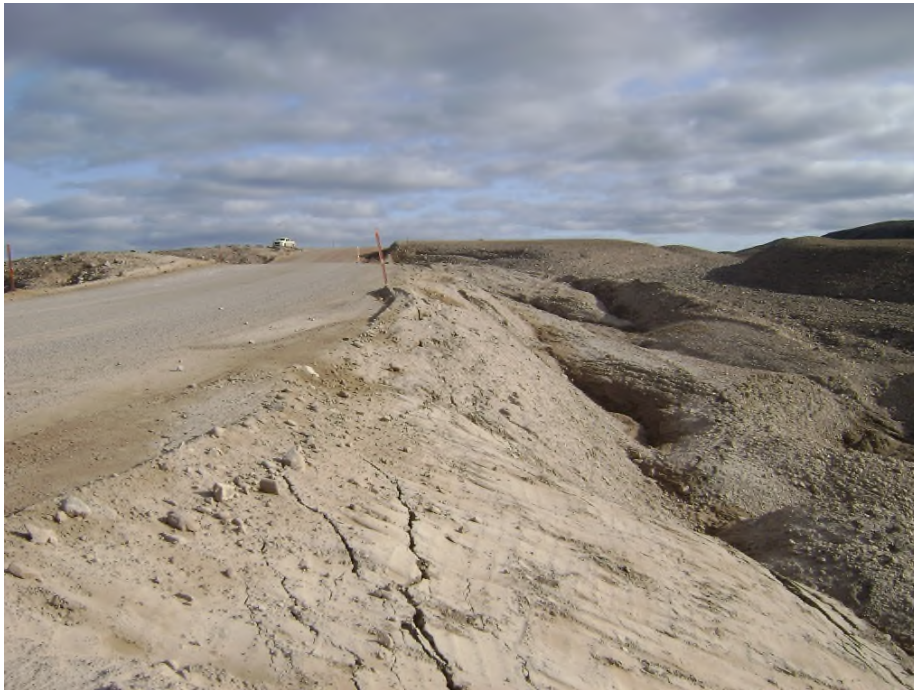
**Photo 23 (2662):**

Pits at KM 63 to 63.4 (Figure 9), continued thaw of ice-rich material beside the realigned road leading to steep side slope and instability of the embankment. Side slopes need to be significantly flattened to provide better thermal protection and stability.

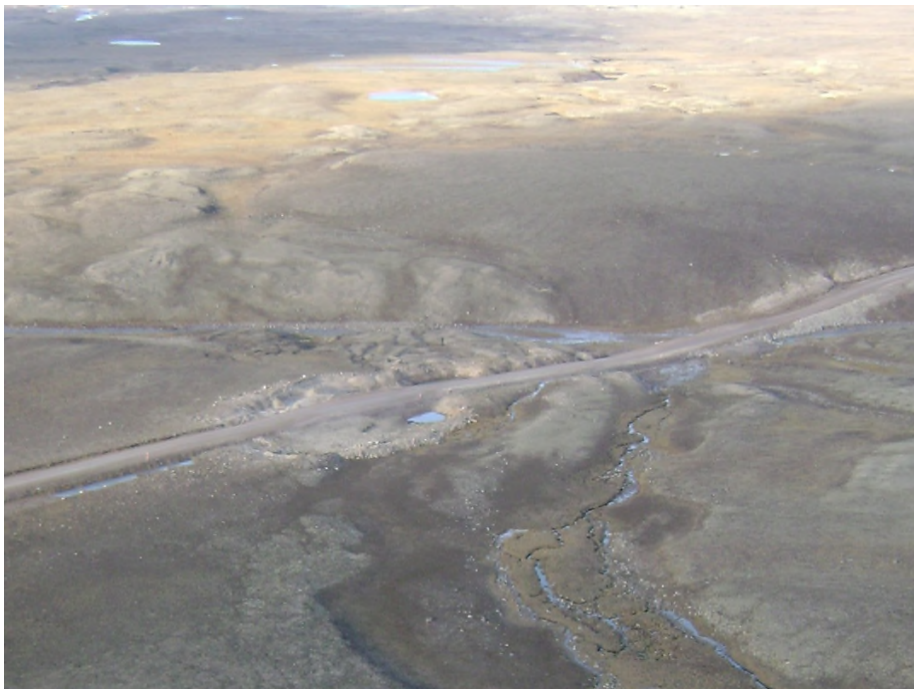
**Photo 25 (2555):**

Pit at KM 72.4 (Figure 10), compare to Photo 24. Thaw settlement is ongoing. Road was rebuilt after a failure occurred at the location of the pond on the left side of the road. Erosion channel from the left side is now more visible. When the water rises in the thaw settlement areas on the right side of the road it flows out and down to the creek and may be a source of sediment.

9. KM 72.4 (pit 22) – See Photos 24 (2014 photo), 25, and 26 (2555, 2653). Discussion with one of BIM's road maintenance superintendents while inspecting this site indicated that there had been a significant rapid failure on the east side of the road with approximately half of the road settling into the ponded water in the old borrow pit. These pits should be remediated as soon as possible. This should involve backfill placement to above the original ground level following removal of as much of the water from the ponds as possible. The potential drainage locations from the pits should be graded appropriately to reduce water velocities, and water not channelized as much as possible (may need to armour the slope below the pits and incorporate check dams as required).

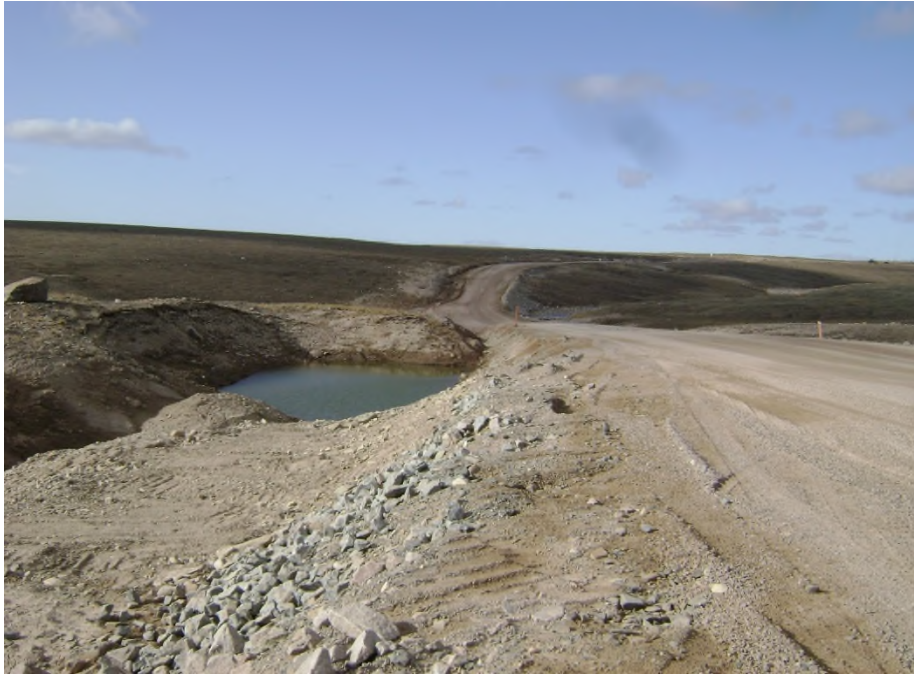
**Photo 26 (2555):**

Pit at KM 72.4 (Figure 10), photo shows right side borrow pit with very deep ponding due to thaw. Embankment shows signs of instability due to very steep slopes. Outlet for ponded water can be seen and is probably the source of sediments noted by the QIA.

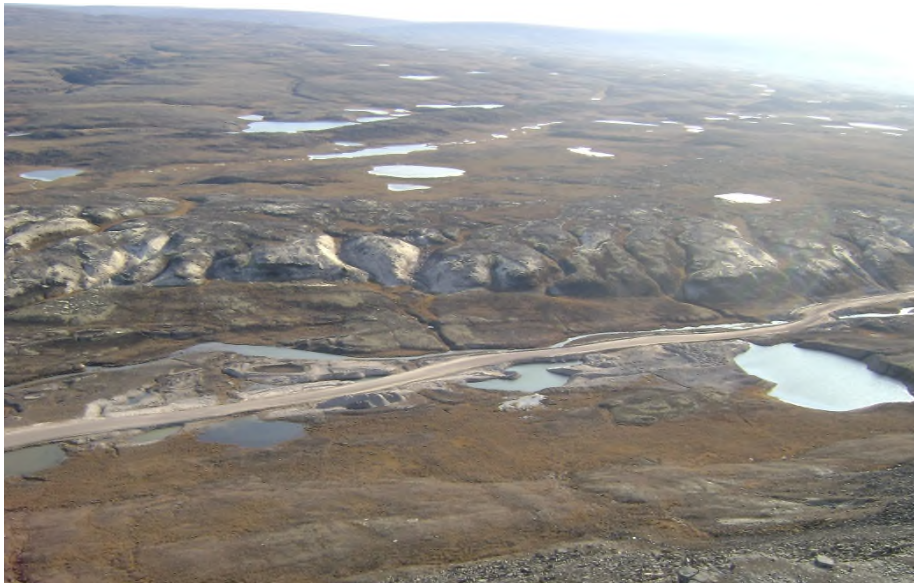
**Photo 27 (2597):**

Pit at KM 89.8 (Figure 12), photo shows borrow pit on the right side with very deep ponding due to thaw (centre of photo). Larger pond on the right is a natural thermokarst pond that existed before the road was constructed and is typical of the ponds that form due to thaw of massive ice bodies. This was likely also the case at the borrow pit location where the removal of the active layer initiated thaw of massive ice.

10. KM 89.8 (pit 14) – See Photos 27 and 28. This is a very deep pond resulting from thaw of a massive ice body initiated because the protective active layer material was removed. Thaw is continuing and appears to be occurring under the side slopes of the road which are very steep and unstable. This pit should have the water removed and then it should be backfilled at least up to the elevation of the original ground. If sufficient material

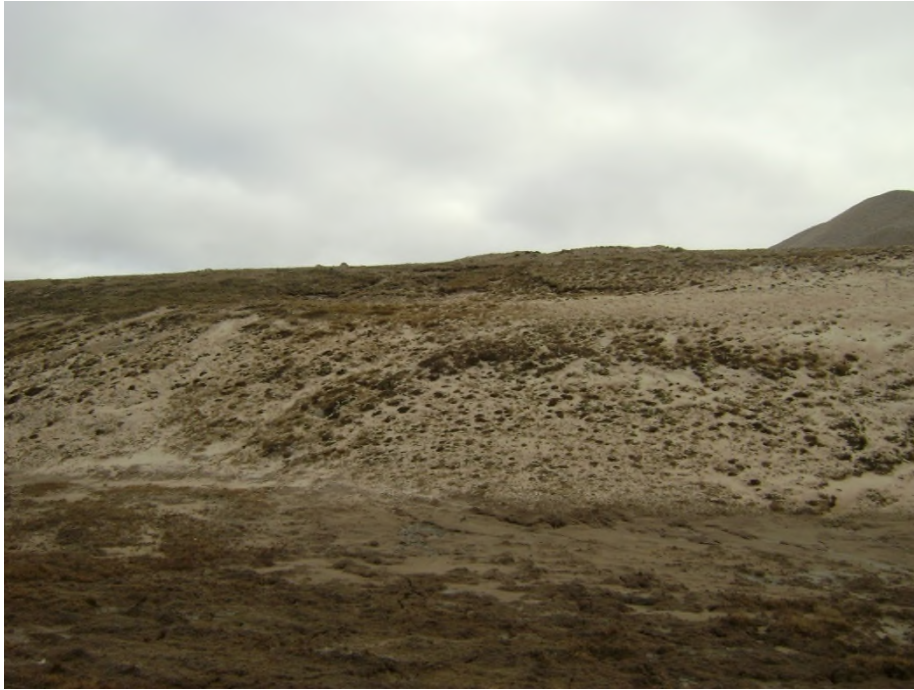
**Photo 38 (2524):**

KM 2.5 slope instability and mud slide adjacent to the Tote Road. Photo on terrace above the road, note evidence of a small instability near the top of the slope and thawed surficial materials on the terrace.

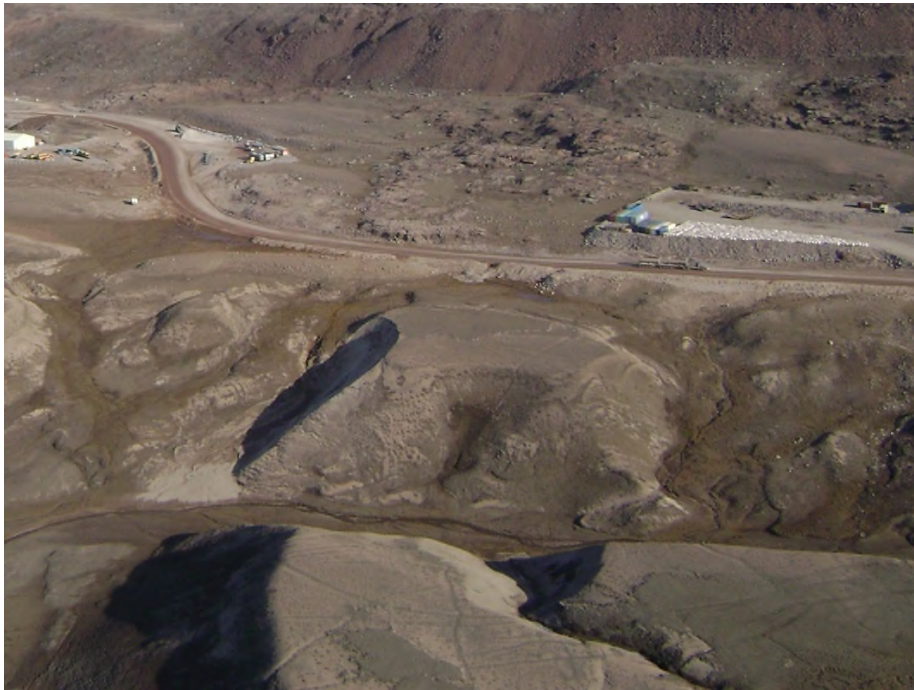
**Photo 39 (2526):**

KM 4.0 erosion location. Erosion is seen on the north (left in the photo) side of terrace (see also photo 40) with a large sedimentation fan near the creek, a wet area on the terrace below the road (see Photo 41) and secondary erosion feature (see Photo 42 on the south (right in the photo) side of the terrace).

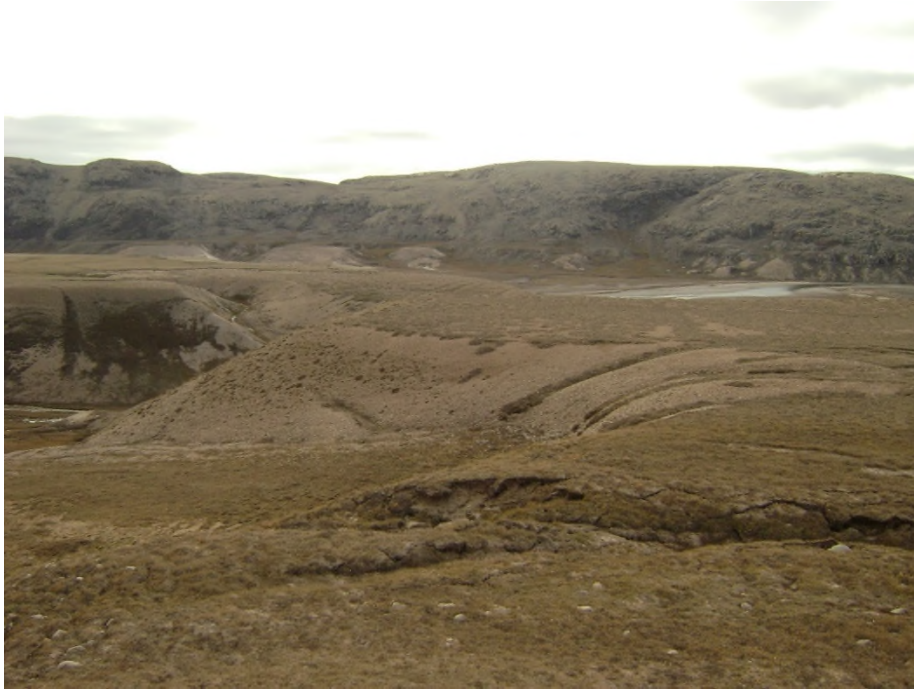
**Photo 42 (2527):**

KM 4.0 erosion location. Photo shows erosion at the edge of the south side of the terrace.

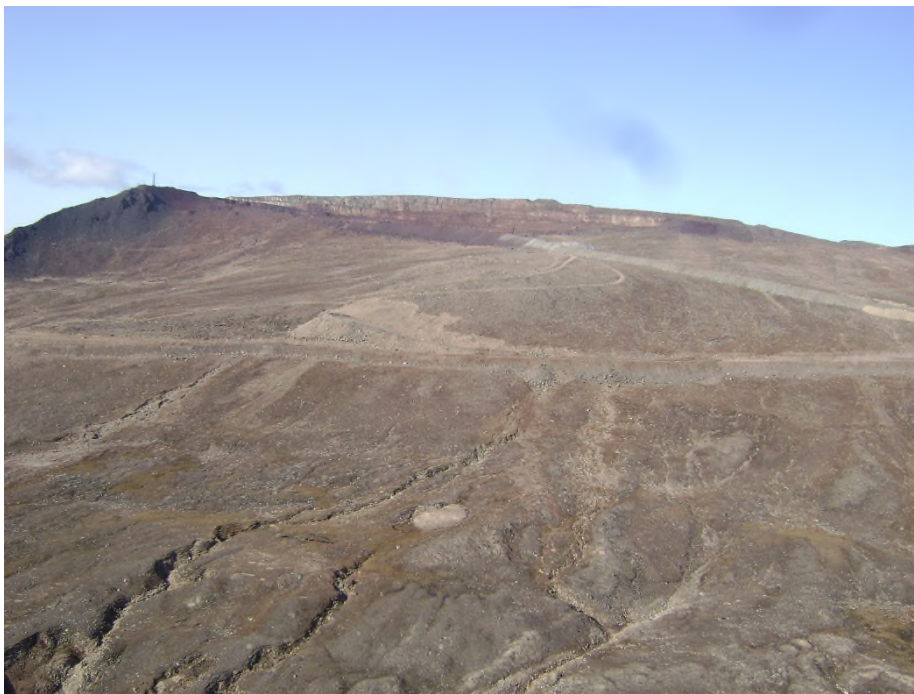
**Photo 48 (2638):**

- Photo 47 is from 2014 and Photo 48 is from the same location in 2019, east of the railway along the deviation to the south of the Tote Road. The location of this natural failure is 71°23'57.07"N, 80°11'57.75"W. This failure has occurred in a deposit of glacial fluvial sand and gravel overlying a large body of massive ice (see Photo 48). The initial trigger for the failure is postulated to be due to surface water erosion at the toe of the plateau that exposed the massive ice body leading to thaw and collapse. From 2014 to 2019 the thaw and collapse has expanded significantly. This type of terrain and the surface expression is a great indicator of the presence of massive ice in this area.

2019 Aerial photo of the natural collapse feature shown in Photo 47. The size of the collapse feature has increased dramatically with extensive meltout of the massive ice. What can be learned from the photo is that terrain with this type of surface expression (“gummie worm”) is likely indicative of deposits of massive ice. This type of terrain is particularly prevalent in the area where the railway deviates to the south of the Tote Road.
